2016 Annual Capital Expenditure Plan (NSUARB P-128.16/M07176)  
NSPI Responses to Small Business Advocate Information Requests

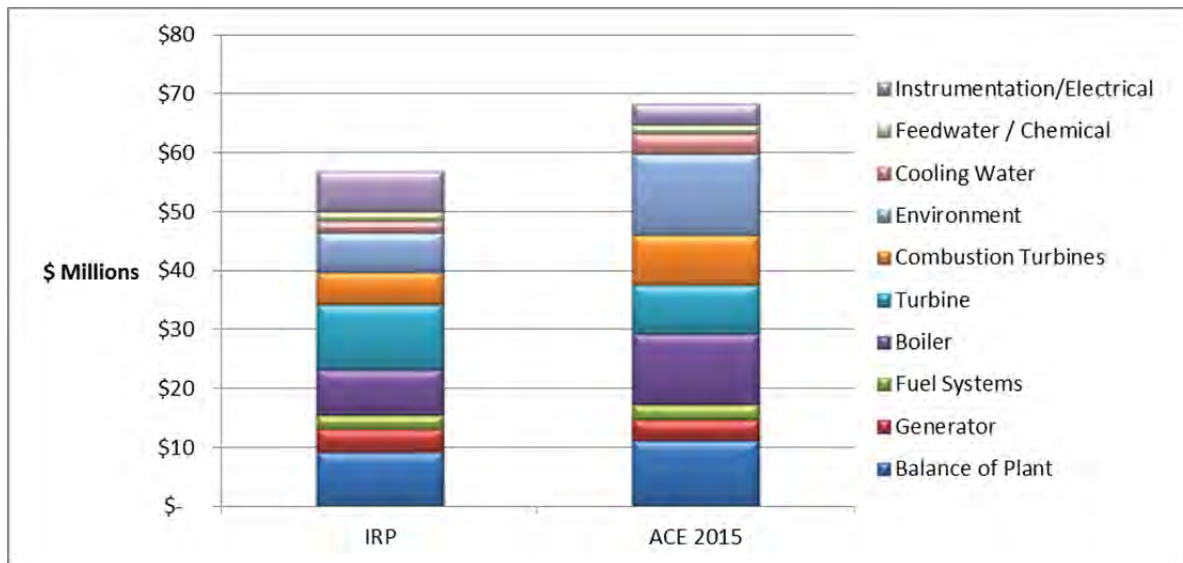
**2015 ACE Plan vs IRP Forecast**

The following table includes the actual dollar figures used in the table above.

Asset Class	IRP	ACE 2015
Balance of Plant	\$9,250,000	\$11,246,083
Generator	\$3,950,000	\$3,463,321
Fuel Systems	\$2,233,750	\$2,641,308
Boiler	\$7,808,750	\$11,956,707
Turbine	\$10,925,000	\$8,361,230
Combustion Turbines	\$5,500,000	\$8,423,251
Environment	\$6,725,000	\$13,700,542
Cooling Water	\$1,962,500	\$3,464,096
Feedwater / Chemical	\$1,750,000	\$1,469,851
Instrumentation/Electrical	\$6,800,000	\$3,619,540

While ACE 2015 is higher than the IRP forecast, the variance is largely due to two items. First being investment in ash sites. As mentioned above, Ash Site investment was leveled throughout the planning period of the IRP however can be expected to have a varying amount of investment year over year. In addition to this, Ash site investment should be looked at as a sunk cost. The majority of this investment is required, and driven by regulatory requirements, even if the associated thermal plant were to be retired today. The second primary driver is investment in our Combustion Turbine fleet. Investment, originally anticipated to occur in future years, was completed in 2015. This increased investment does not have an effect on alignment with the IRP as all Combustion Turbines are anticipated to operate throughout the IRP Planning Period.

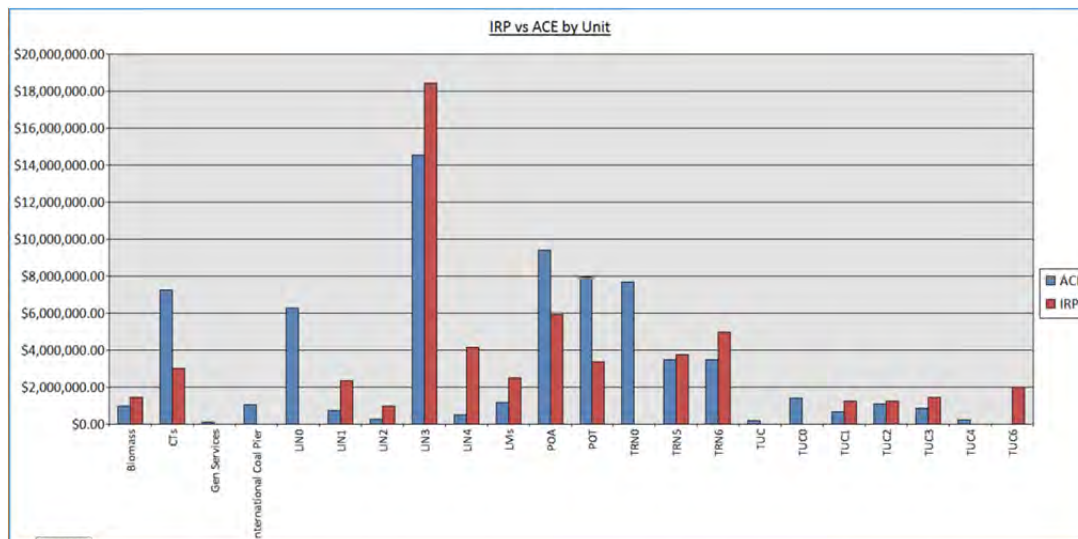
In addition to the above, the investment in the units that are anticipated to be retired within the planning period has remained consistent with IRP values. Increases from the IRP capital forecast have primarily occurred on the thermal units that will be operational throughout the Planning Period as the chart below shows.
