2017 Annual Capital Expenditure Plan (NSUARB M07745)  
NSPI Responses to SBA Information Requests

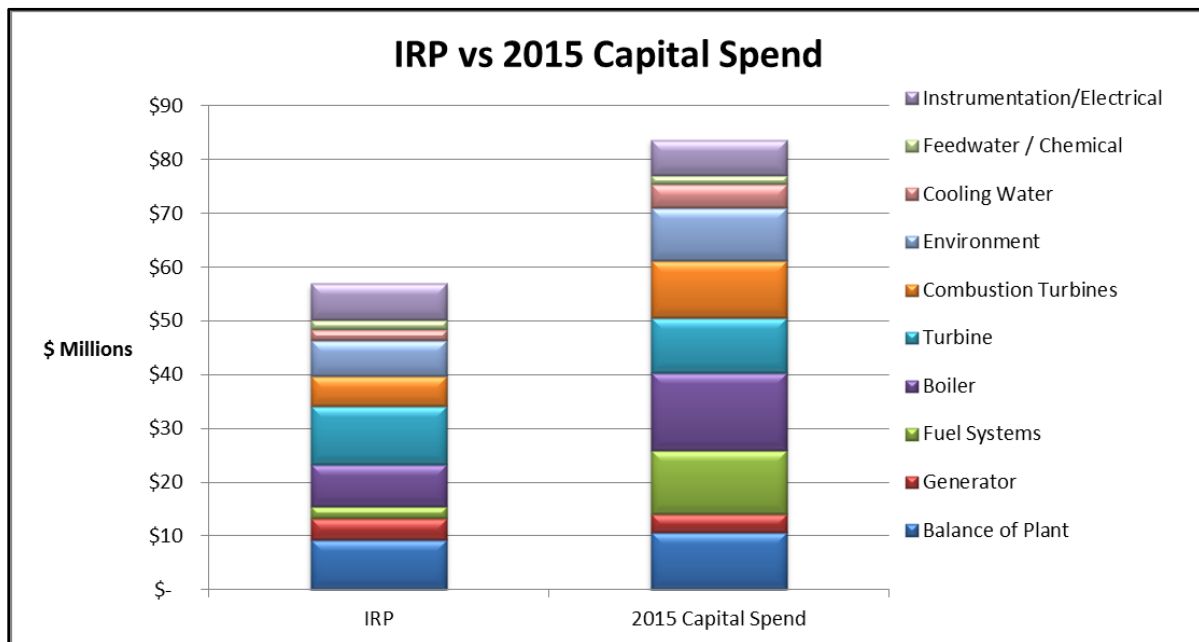
9 Please refer to the charts below for IRP comparisons to 2015 actual capital spend and 2016  
10 forecasted capital spend. As discussed in the 2017 ACE Plan, the 2014 IRP was completed using  
11 only 2014 dollars and did not include any form of inflation for future years and was at a time  
12 where the Canadian dollar was relatively on par with the US dollar. When applied to the 2014  
13 IRP forecast, a conservative estimate of the increase in that forecast would be \$6 million.

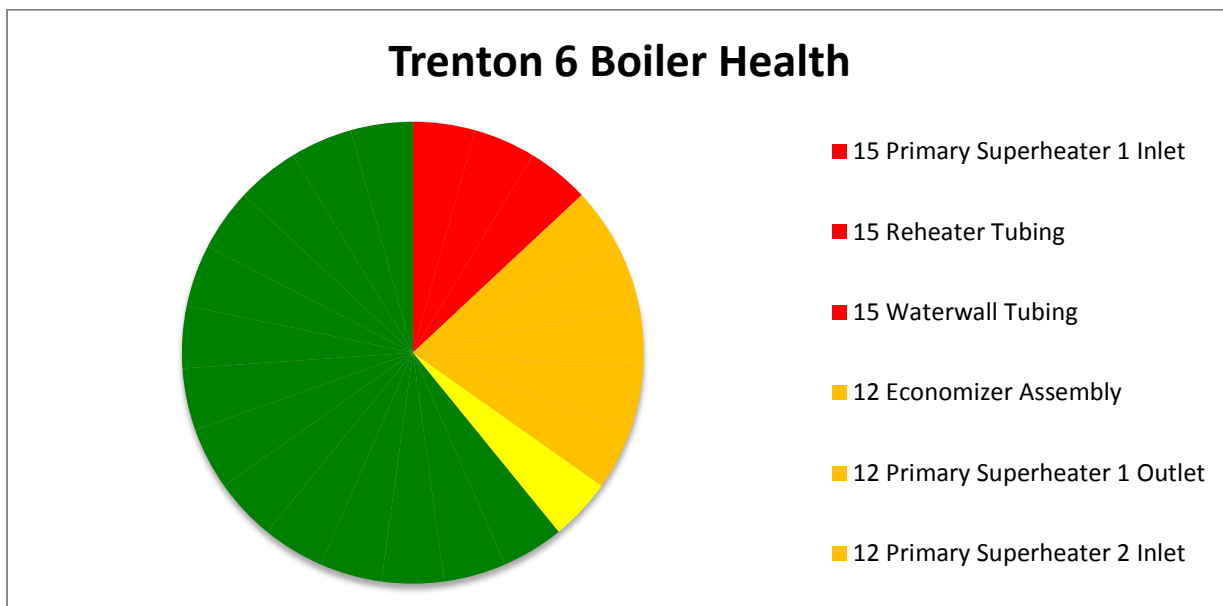
8 The figure below shows the health assessment of Trenton Unit 6 boiler. Consistent with NS  
9 Power’s asset management risk ranking methodology, each piece of major equipment is  
10 evaluated on condition (1-5) and criticality (1-5) to produce a risk ranking (1-25). These risk  
11 rankings are displayed graphically below to demonstrate the overall health of the boiler.  
12 Sections of the boiler that have been evaluated to be in very poor condition are shown in red,  
13 while sections which were evaluated to be in acceptable condition are shown in green and are not  
14 detailed fully in the graph below.

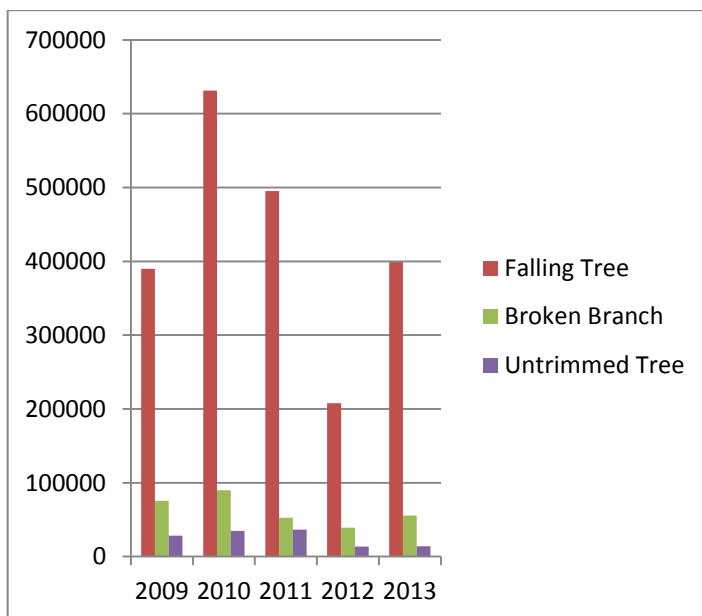
Tree caused outage slide

- In most cases ROW's were clear of trees when power poles originally installed.
- Arthur related outages were due to trees too close to the power lines.
- It was many healthy trees that broke; they were hazard trees, but not danger trees. It was the trees as shown on the right of the Roadside Management slide that caused the outages.

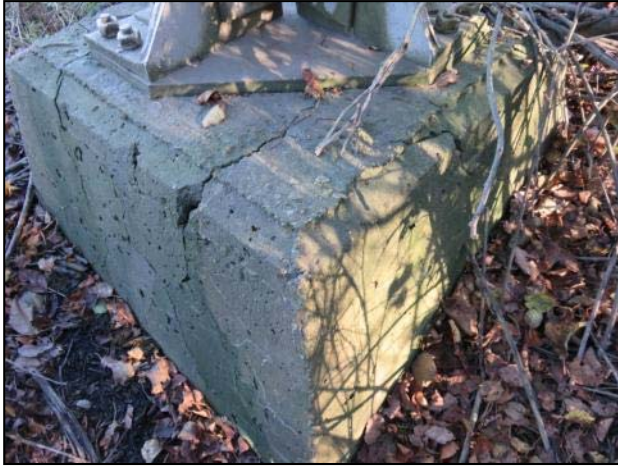
Ph 1 – Foundation cracks (1 of 3).

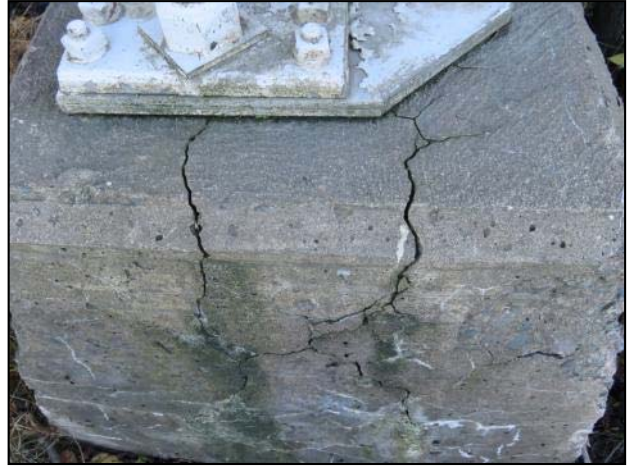
Ph 2 – Foundation cracks (2 of 3).

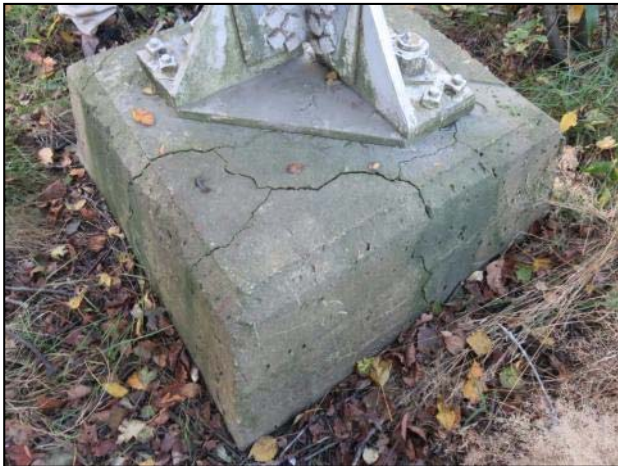
Ph 3 – Foundation cracks (3 of 3).

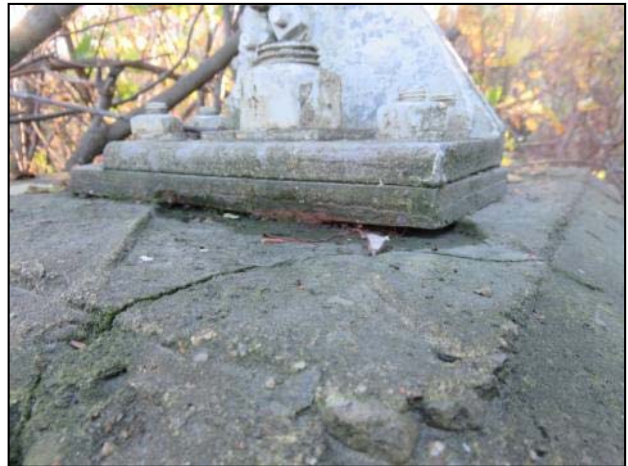
Ph 4 – Gap beneath base plate.

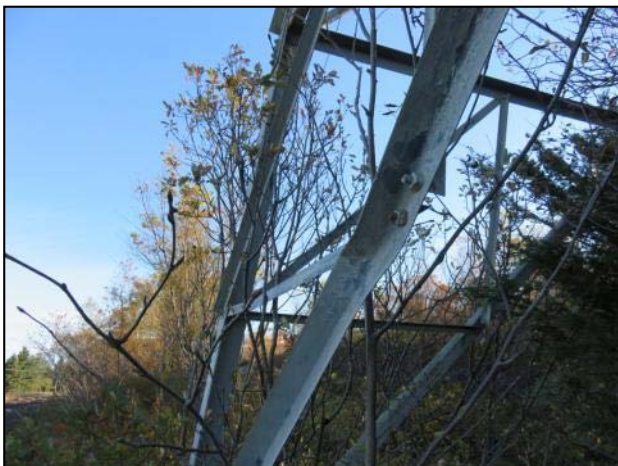
Ph 5 – Bent tower diagonal (2 places).

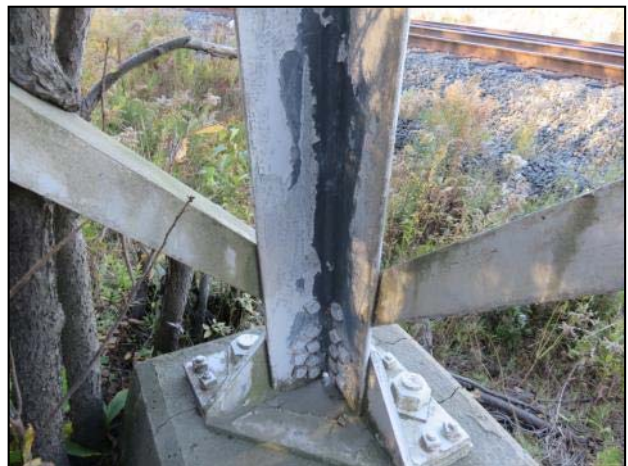
Ph 6 – Paint condition (typ.).

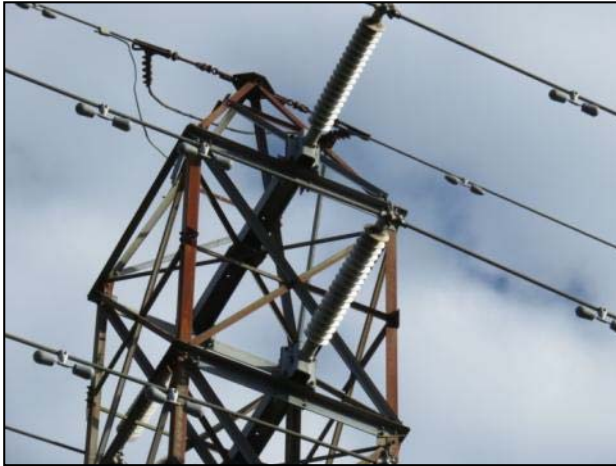
Ph 1 – Corroded tower members (1 of 3).

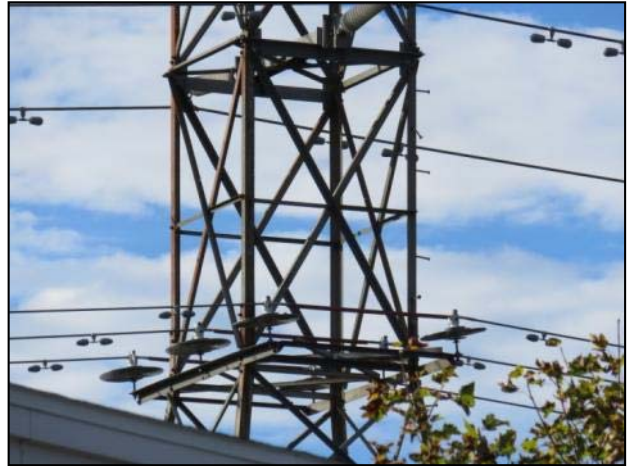
Ph 2 – Corroded tower members (2 of 3).

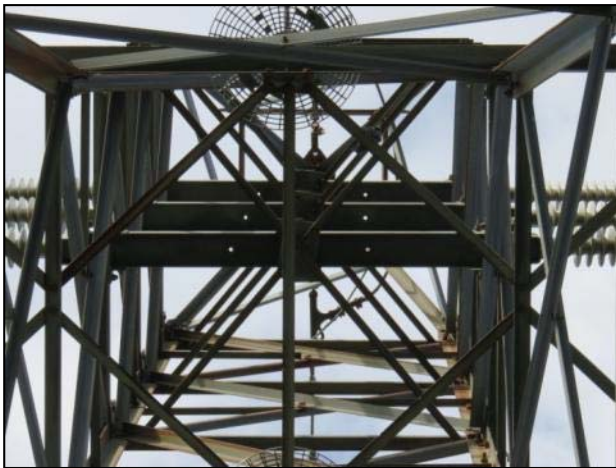
Ph 3 – Corroded tower members (3 of 3).

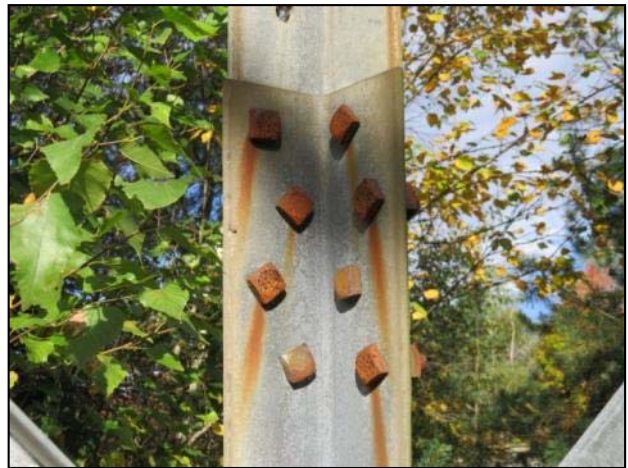
Ph 4 – Corroded bolts (typ.)..

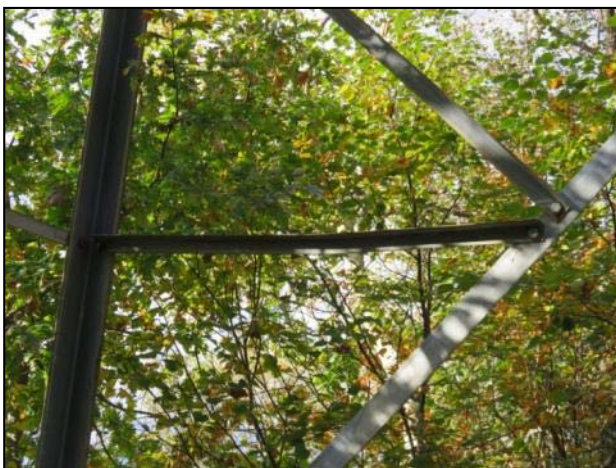
Ph 5 – Bent tower member.

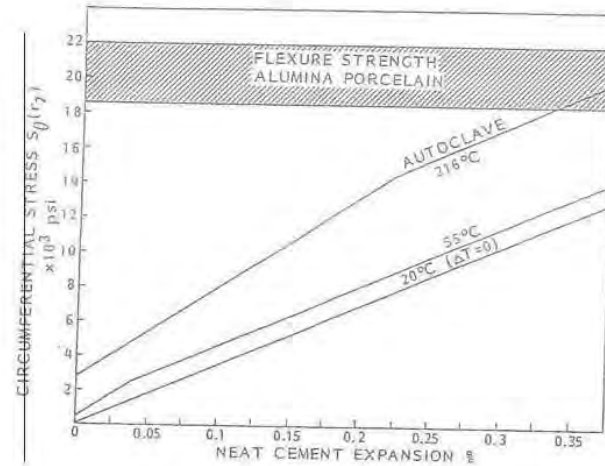
Fig. 5. Circumferential stress  $S_{\theta}(r_2)$  in alumina porcelain for cement expansion in per cent.

Although the range for flexure strength shown in Figs. 4 and 5 are for sound porcelain, flaws acquired in manufacturing will greatly reduce the cement expansion necessary for fracture.

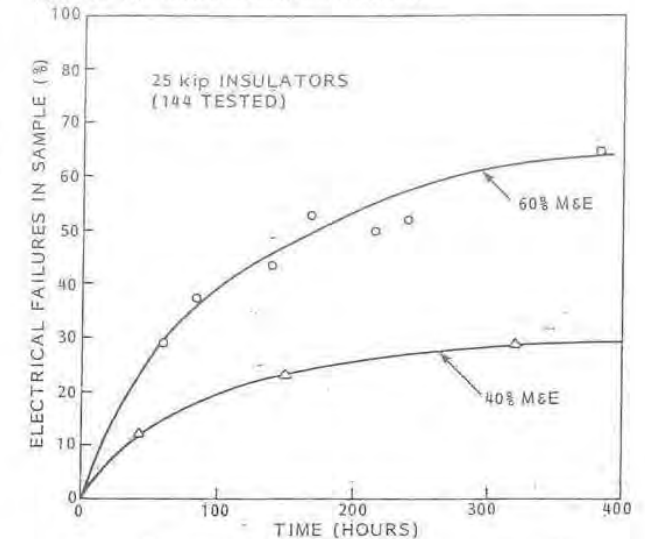
Fig. 9 shows the results of time-load tests on 25 000 lb insulators. The insulators were held at constant tension (60 per cent of M&E strength) for 16 days. All but a few of the 96 units were unused 1965 insulators that were stored outdoors in crates for 17 years. Initially, the insulators were hi-pot tested before the string was assembled. After the string was tensioned, the insulators were retested and

the hi-pot test repeated seven times during the 16 day constant tension period. The failure rate was found to increase with time, reaching approximately 65 per cent in 16 days. Failure was due to radial fracture of the porcelain dielectric, some of which were visible in the shells of the insulators.

Fig. 9. Time-load test on unused 25 000 lb insulators manufactured in 1965.

- i) Deterioration rate of the insulator at the dead end tower is higher than that of the suspension tower.
- ii) From the time load test result shown in Fig. 9, the heavier load test shows the higher electrical failure rate.

Thus, the results presented by the author in Fig. 7 through Fig. 9 can be interpreted as being indicative of the effects of reduction in stress relieving ability of bituminous coatings with time.

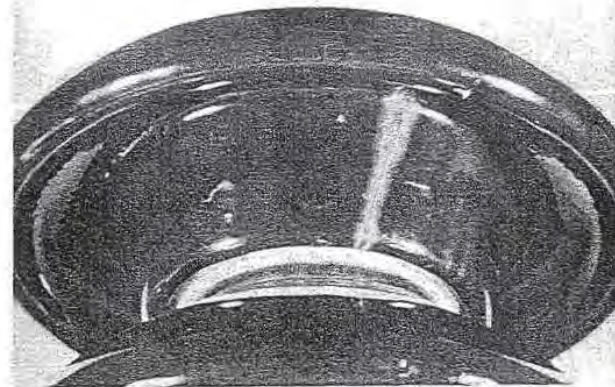
On aged insulators, autoclave tests produced radial cracks that duplicated those found in insulators in the field. This was demonstrated not only in suspension insulators, but also in apparatus cap-and-pin insulators (Fig. 10).

Fig. 10. Aged apparatus cap-and-pin insulator subjected to cement autoclave expansion test.

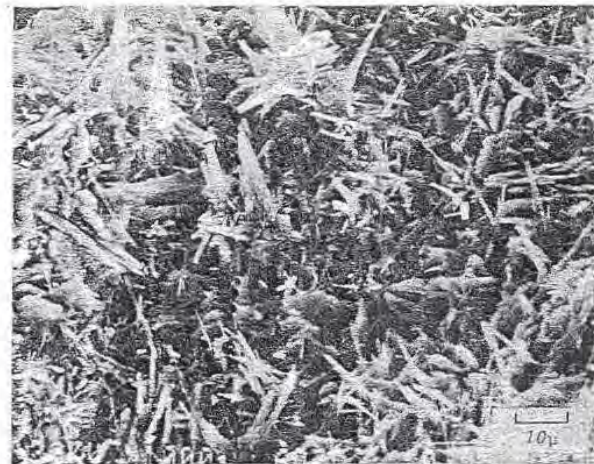
One of the four binding compounds of portland cements is tricalcium aluminate [11]. Its presence is undesirable as it contributes little to the cement except at early ages. The reaction of pure tricalcium aluminate is rapid and leads to immediate hardening of the paste which is referred to as flash set. To retard the setting of the paste, gypsum is added to cement clinker. Gypsum and tricalcium aluminate react to form insoluble calcium sulphoaluminate (3CaO·Al<sub>2</sub>O<sub>3</sub>·3CaSO<sub>4</sub>·3H<sub>2</sub>O). Gypsum, when present in excess, will cause excessive expansion after setting and hardening owing to the continued formation of calcium sulphoaluminate in the presence of moisture. The presence of this compound, characterized by long needle-like shapes as in Fig. 11, was confirmed in insulator cement, by electron dispersive analysis. The elemental weight ratios of Ca:Al, Ca:S and S:Al were found to compare quite closely to the expected molecular weight ratios for 3CaO·Al<sub>2</sub>O<sub>3</sub>·3CaSO<sub>4</sub>·3H<sub>2</sub>O. In several insulator cements, the needle-like shape crystals were found predominantly in voids where presumably moisture collects.

Fig. 11 Scanning electron microscope photograph of tricalcium sulphoaluminate crystals in an insulator cement at 1000 X.

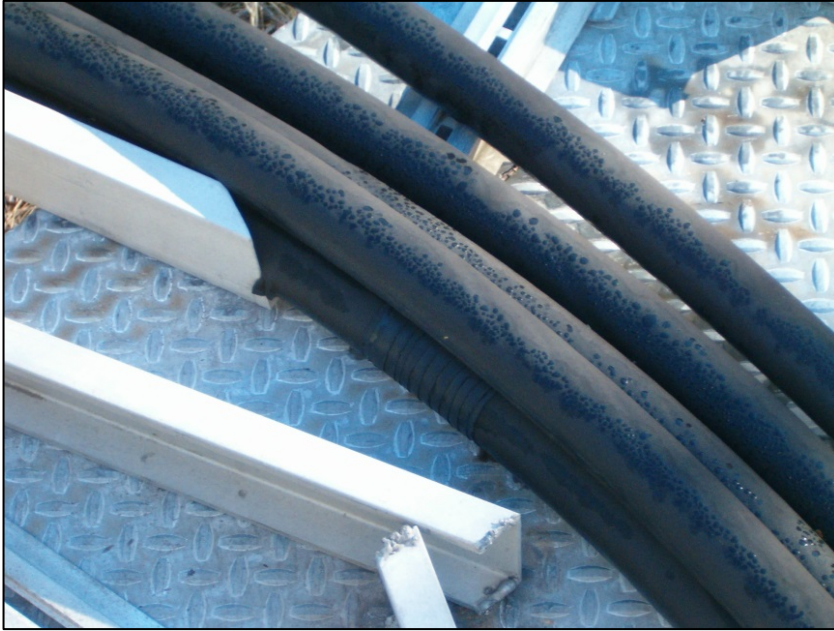
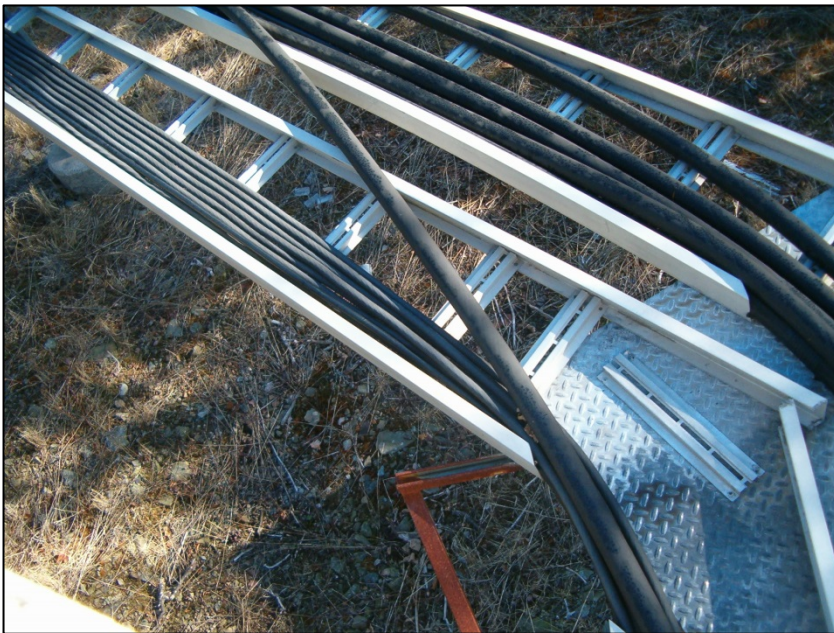
14 (a) These cables have exceeded the expected useful life by 10 years and are showing signs of  
15 deterioration. NS Power does not have specific recent documentation on the condition of  
16 these cables, but visual inspections are completed by NS Power technical staff on a  
17 monthly basis and have confirmed the cables are showing signs of deterioration. The  
18 photos below show damage to the outer jacket of the cable from the cable tray and  
19 deterioration of the jacket due to extended exposure to the environment. The electrical  
20 testing that would be required to confirm the insulation properties of the cables is a  
21 destructive test which these cables could not withstand.

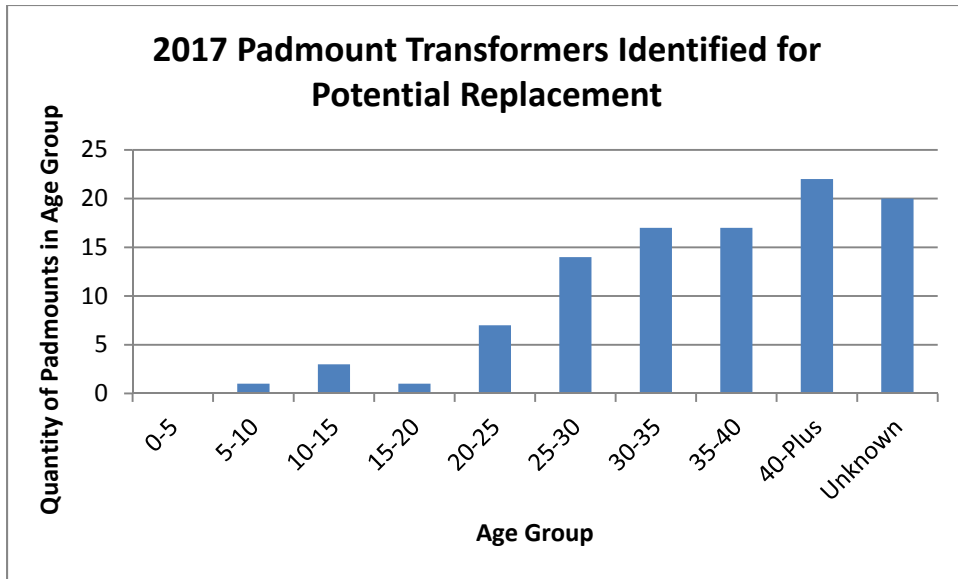
11 (a) The 80 padmount transformers that will be targeted for replacement are currently being  
12 prioritized based on the 102 padmount transformers that were identified during recent  
13 inspections for potential replacement. The table and chart below provide the age profile  
14 of the 102 transformers identified during recent inspections. A manufacture year is  
15 deemed “Unknown” if it is deteriorated to the point that it is no longer legible or if it is  
16 not listed on the padmount transformer nameplate.

<b>Year</b>	<b>Age (Years)</b>	<b>Quantity</b>
1983	34	1
1982	35	2
1981	36	1
1980	37	2
1979	38	2
1978	39	8
1977	40	4
1976	41	4
1975	42	3
1974	43	8
1973	44	6
1971	46	1
Unknown	Unknown	20

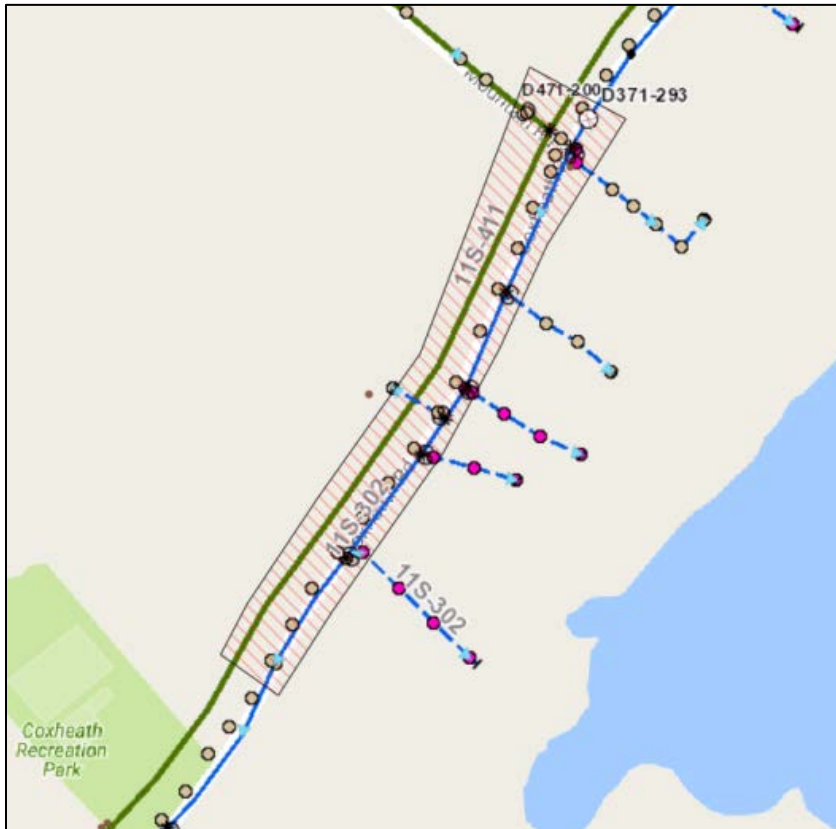
- 19
- 20 **(a) Phase 1 provided for the replacement of 17 poles. The existing, deteriorated, 45-foot**  
21 **poles were replaced with 50-foot poles in order to provide the appropriate spacing**  
22 **between two circuits, in compliance with current NS Power standards. Additional**  
23 **replacements included insulators and transformers. Replacements were done along**  
24 **Coxheath Road from Mountain Road to the Coxheath Recreational Park, as shown in the**  
25 **following image.**
- 26
